ANALYSIS AND TESTING OF A METALLIC REPAIR APPLICABLE TO PRESSURIZED COMPOSITE AIRCRAFT STRUCTURE

ABSTRACT

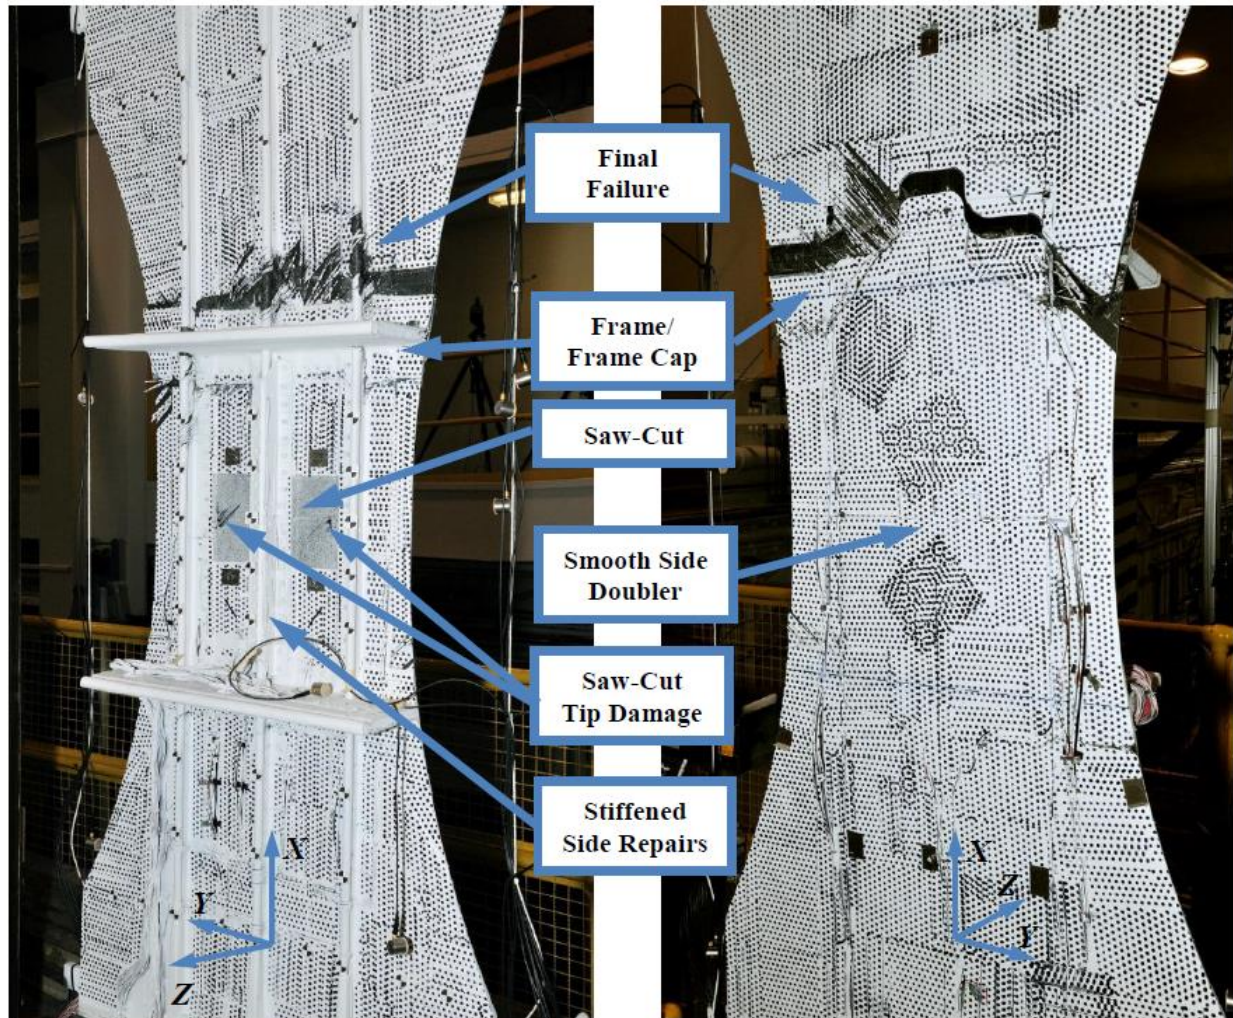
The panel was tested at the NASA Langley Research Center (LaRC) in the one million pound load-rated test machine. The test was conducted at room temperature. The tension load was applied through displacement-control and was introduced at the rate of 1.27 mm (0.05 in.) per minute. The final panel failure occurred at the loading of 1,085 kN (244,000 lbf). After applying a statistical scatter knock-down factor of 15%, this load corresponds to the working stress allowable of 480 MPa (69.6 ksi). Recall from section 1.3 that this exceeds not only the previous working stress allowable, but also the design objective of 414 MPa (60 ksi). The failure mode is illustrated in Figure 4. The failure occurred away from the center section of the panel, i.e., away from the initial saw-cut damage, generally in the vicinity of the top foam-filled frame.

Figure 4. Repaired tension panel failure away from the saw-cut damage.

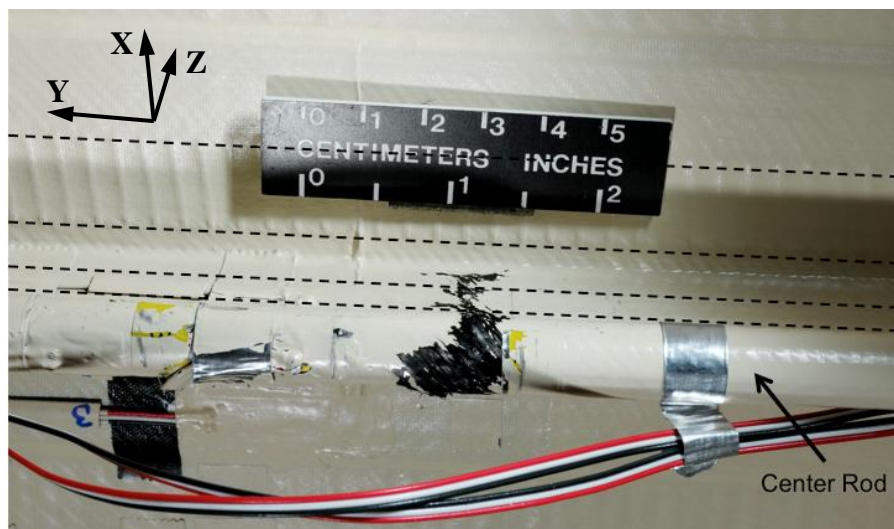
The panel was initially tested in its pristine condition up to 126.86 kPa (18.4 psi), considered the design ultimate load (DUL). No identifiable damage occurred during this test. Subsequently, the stiffening rod of the first off-center stringer and the skin section between this stringer and the center stringer were impacted with an energy level resulting in BVID [7]. After impact, the pressure panel was again tested up to the DUL without any signs of additional damage. Next, the pressure load was increased until failure, which occurred in a non-catastrophic fashion at 193 kPa (28 psi). The panel retained its pressurization capability and the pressure was further increased to 207 kPa (30 psi). After the test the only visible damage identified was in the center stringer (i.e., not the impacted stringer), slightly off its mid-span location. The stiffening rod of the stringer was compression-crushed and the stringer's web exhibited damage as shown in Figure 7. The extent and location of the damage presented an opportunity to reuse the panel for testing in a repaired configuration. Note, that the damage of the center stringer occurred within its section that would be tapered off before repair installation, as shown on the tension panel in Figure 2. Therefore, after tapering the center stringer and introducing the same 0.152 m (6 in.) long by 6.35 mm (0.25 in.) wide mid-bay to mid-bay saw-cut, the three metallic repair components identical to those described in section 2.1 were installed on the panel. The smooth side of the repair panel with the doubler is shown in Figure 8 and the two metallic angles installed on the stiffened side of the panel are shown in Figure 9. The inset in Figure 9 shows the tapered stringer before the two repair angles were installed.

Figure 7. Crushing failure of the center stringer. The dashed lines identify stitch locations.
